Manhole Inspection Summary

Manhole # S41CC_015MH

Location Address: **825 n.caroline st**

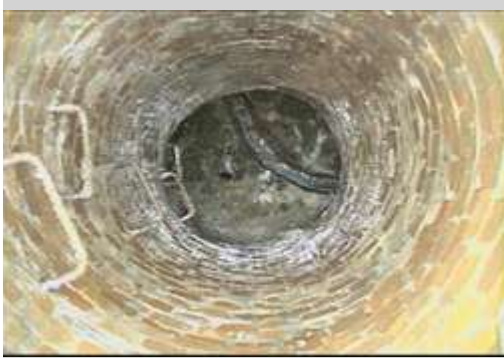
Defect 1

Steps Count: **9** Missing: **0** ☒ Corroded

Surcharge ☒ Evidence Of Surcharge Depth: **3** (ft.) ☐ Active Surcharge Present

corroded steps, evidence of surcharge

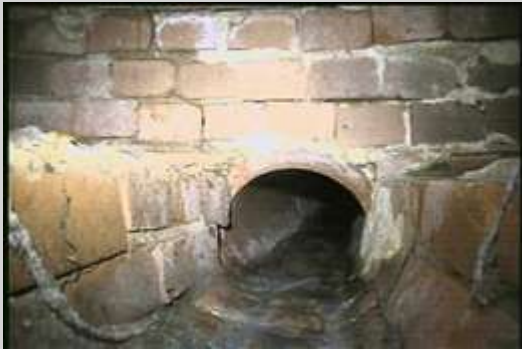
12 O'Clock Outflow

8 in. Circular Gravity Sewer
Pipe Out @ 12 O'Clock

Invert Depth: 13.10 (ft.) Flow Characteristics: **Slow**

Infiltration: **None** Pipe Seal Cond: **Unknown**

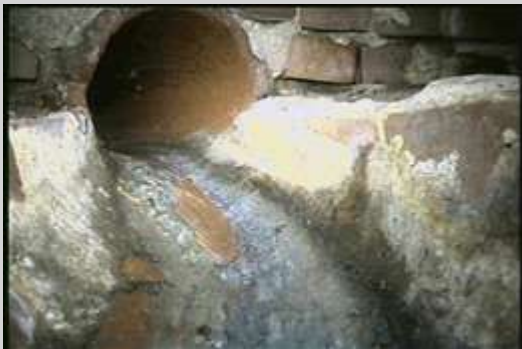
5 O'Clock Inflow

8 in. Circular Gravity Sewer
Pipe In @ 5 O'Clock

Invert Depth: 12.80 (ft.) Flow Characteristics: **Slow**

Infiltration: **None** Pipe Seal Cond: **Unknown**
